Aldridge Place Local Historic District

HISTORIC STRUCTURES SURVEY

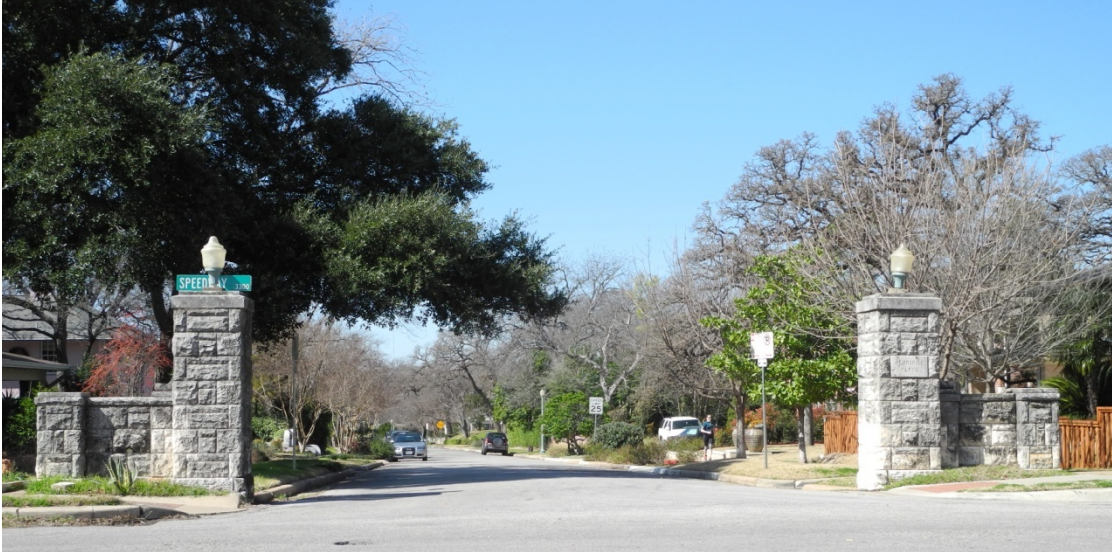
ADDRESS: Aldridge Place Columns at West 33rd Street and Speedway

A hallmark of the early 20th century City Beautiful movement, a pair of 2-tiered rusticated limestone entry gates flank 32nd Street at its intersection with Speedway Blvd. The words "Aldridge Place" are incised on outward-facing stone panels set into the tallest columns. Bulb-like light fixtures, similar to neighborhood streetlights, surmount the pillars. Excellent, intact example of Rustic style "street furniture". Retains high level of integrity, reflects historic and architectural trends of its time, and contributes to the historic district.

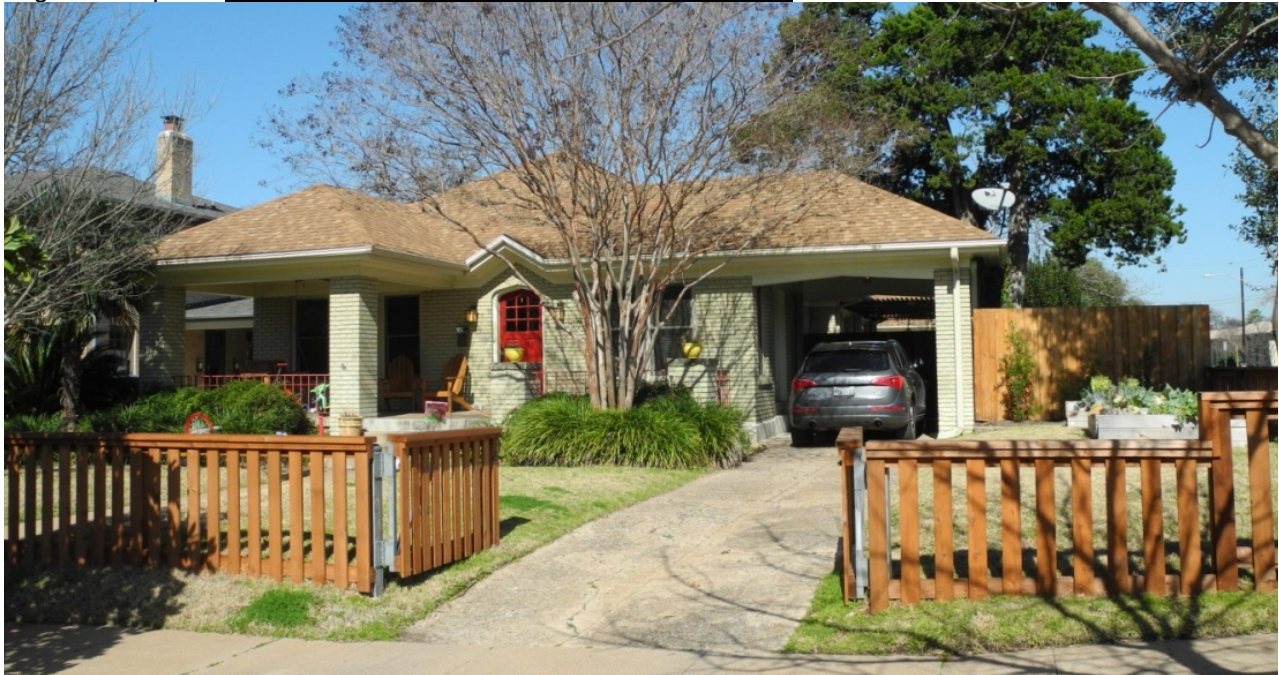
ADDRESS: 100 W 33rd St.

1-story brick Prairie style house with offset porch, porte cochere all under cross-hipped roof with wide, overhanging eaves: porch and porte cochere supported by substantial square brick columns, Small gabled entry porch with brick lined Moorish arch over door. Paired and tripled 1/1 double hung windows. This good, rare example of a 1-story Prairie School house retains high levels of all 7 aspects of integrity, reflects historic and architectural trends of its time, and contributes to the historic district.

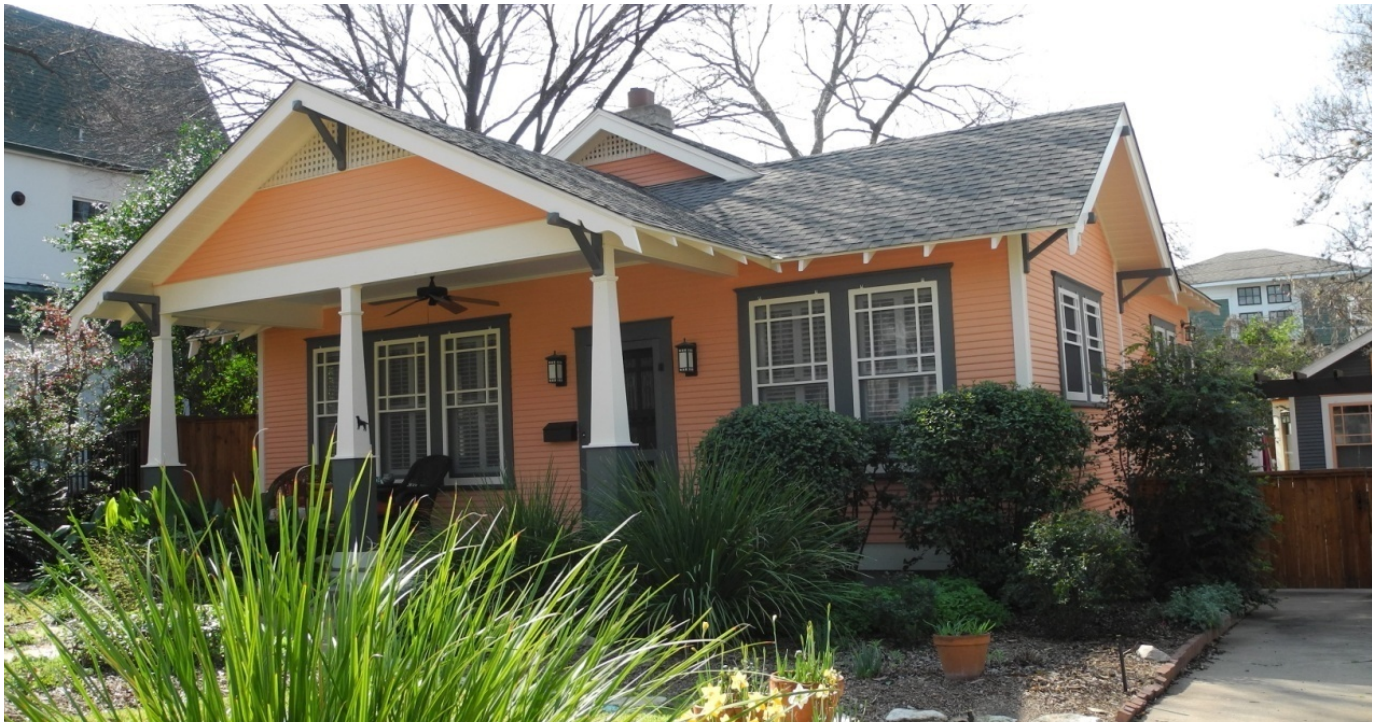
1-story cross-gabled Craftsman bungalow with false beveled siding, triangle knee braces, lattice-work gable vents, exposed and notched rafter ends, and long tapered porch posts on box piers. Paired and tripled 1/1 windows with cross-hatched screens. Original porch posts replaced with new, elongated posts. Good example of Craftsman bungalow despite post replacement. Retains high levels of integrity otherwise, reflects historic and architectural trends of its time, and contributes to the historic district.

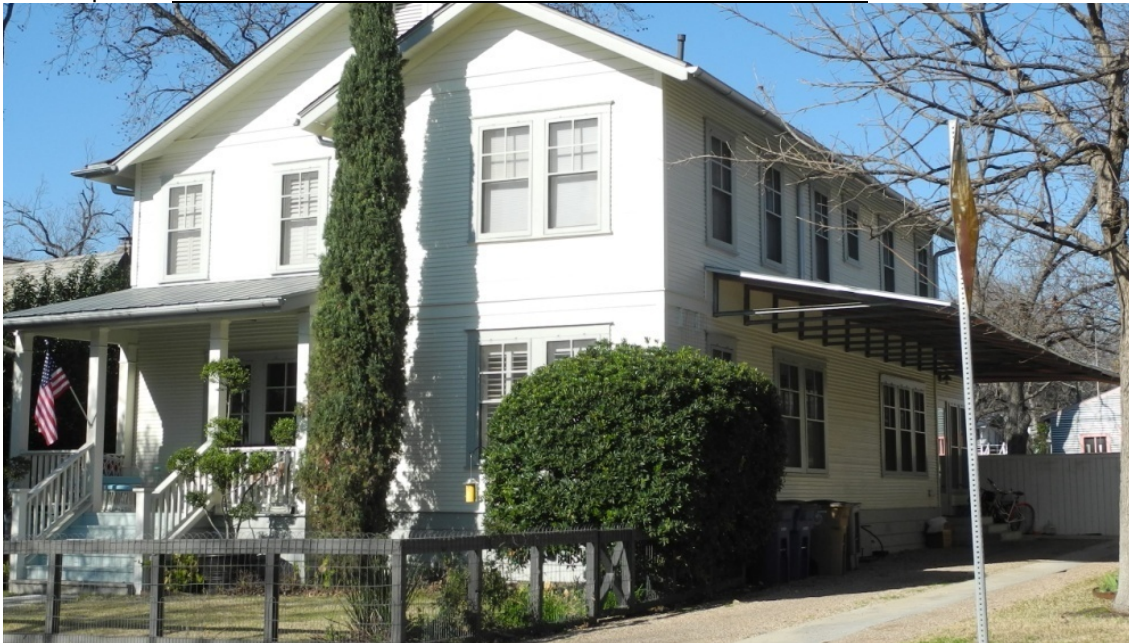
2-story front-gabled vernacular frame house with a slightly extended front-gabled wing and attached shed-roofed porch. Original 1-story house replaced by 2-story house 1935-1962. Recent alterations include roof and window replacement; addition of highly-visible shed-roofed canopy along east façade. Current house is not recognizable to the period of significance. Lacks integrity of design, materials, workmanship, and feeling and therefore does not contribute to the historic district.

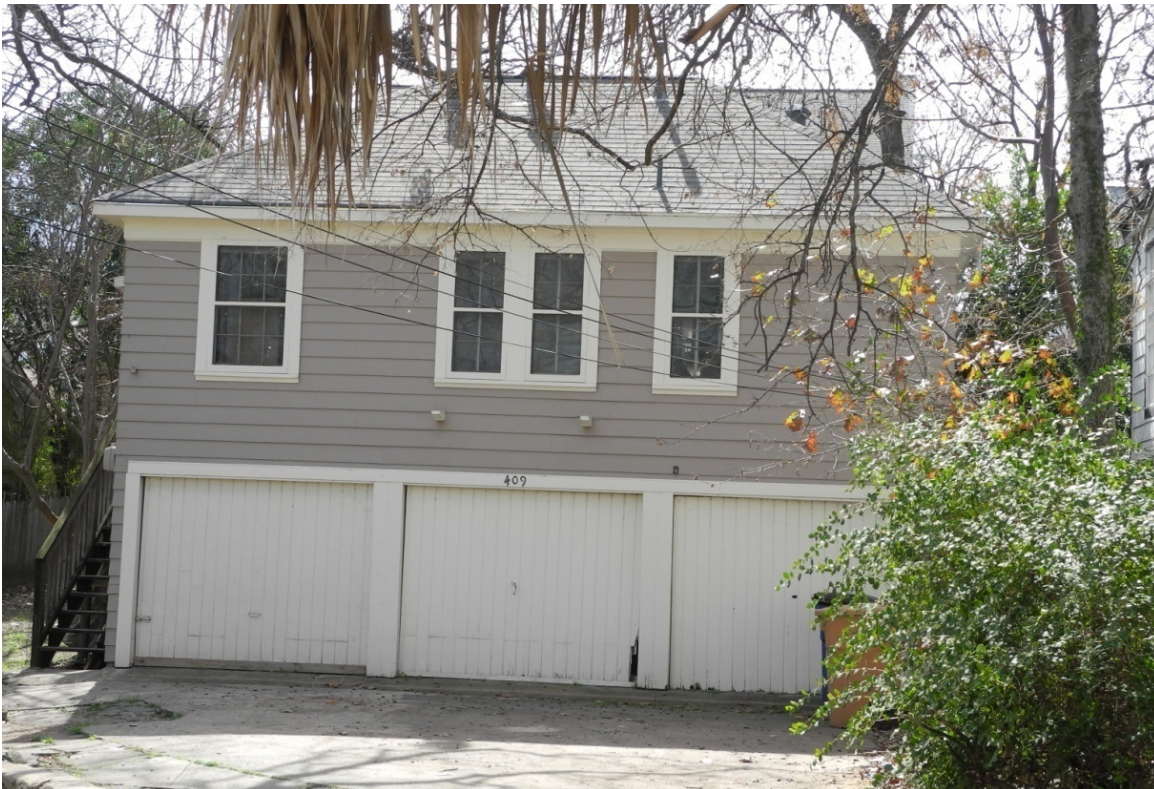
2-story hipped-roof garage apartment with wood lap siding. 3-bay garage with vertical board replacement doors. Apartment accessed by exterior stair to 2nd floor shed-roofed entry porch. Apartment has various 6/6 and 4/4 wood sash windows. Historic period garage apartment retains high levels of all 7 aspects of integrity, reflects historic and architectural trends of its time, and contributes to the historic district.

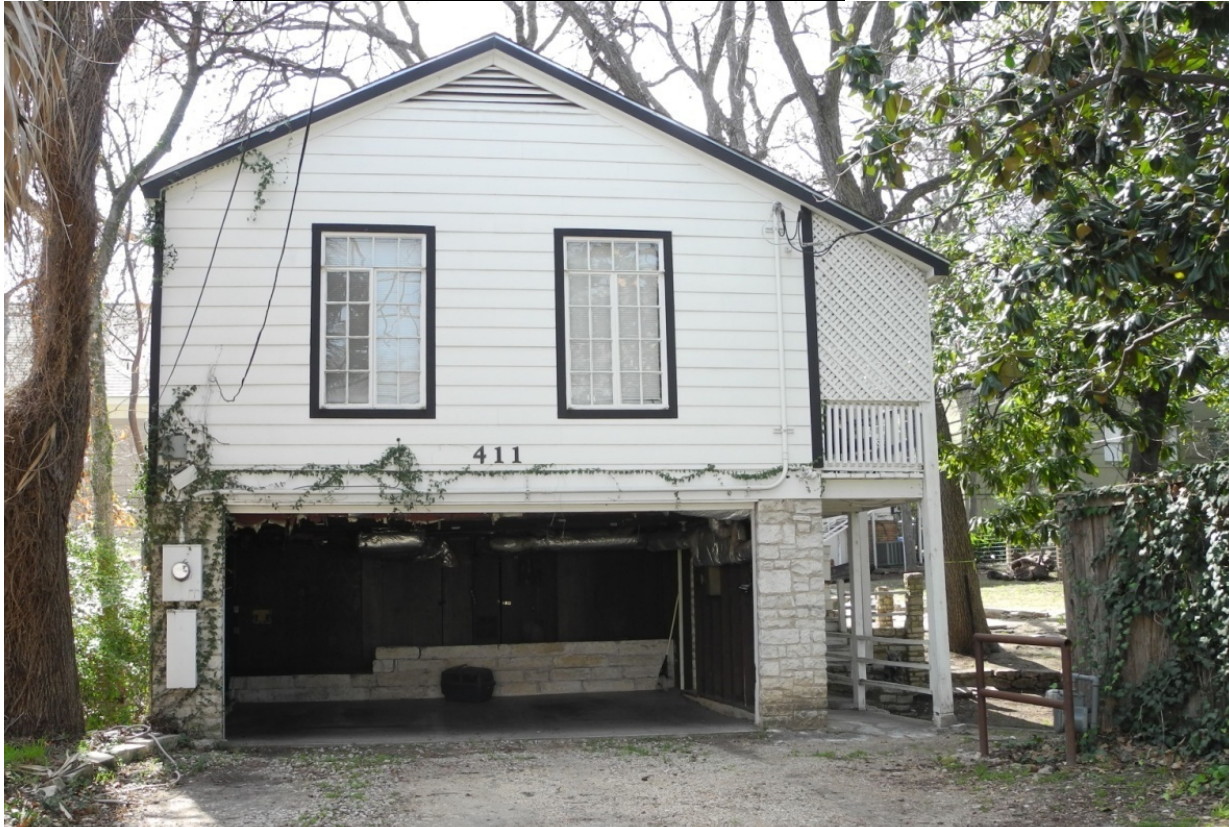
2-story garage apartment with open 2-car garage bay below and side-gabled apartment with elevated full façade porch accessed by exterior stair above. First floor/foundation is uncoursed stone; 2nd floor has wood lap siding and multi-light wood casement windows. Historic period garage apartment retains good levels of all 7 aspects of integrity, reflects historic and architectural trends of its time, and contributes to the historic district.

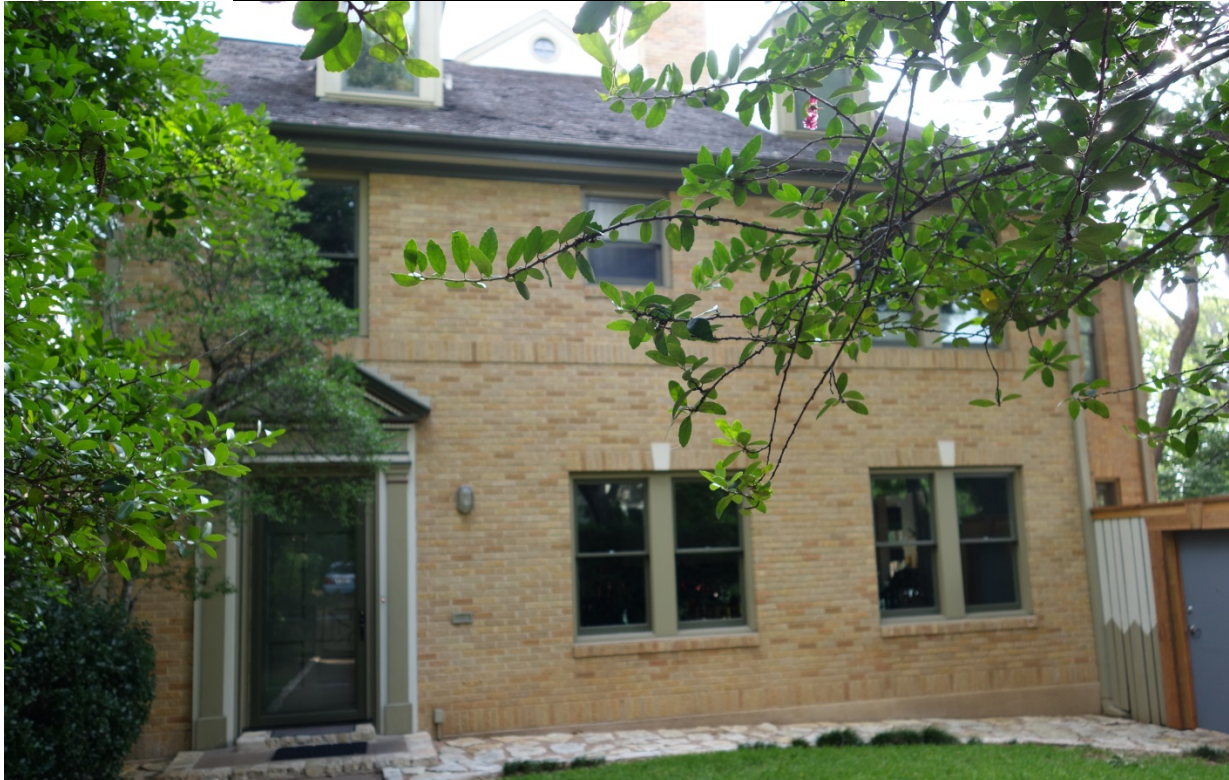
2.5-story side-gabled Colonial Revival house with flat façade, broken pediment entry, recessed 2-story gabled wing, and front-gabled dormers. Brick veneer walls and chimney; stucco in side gables. Nonhistoric 3rd floor; roof form and dormers may have been added or modified. This large Colonial Revival house may have been significantly modified since its original construction.

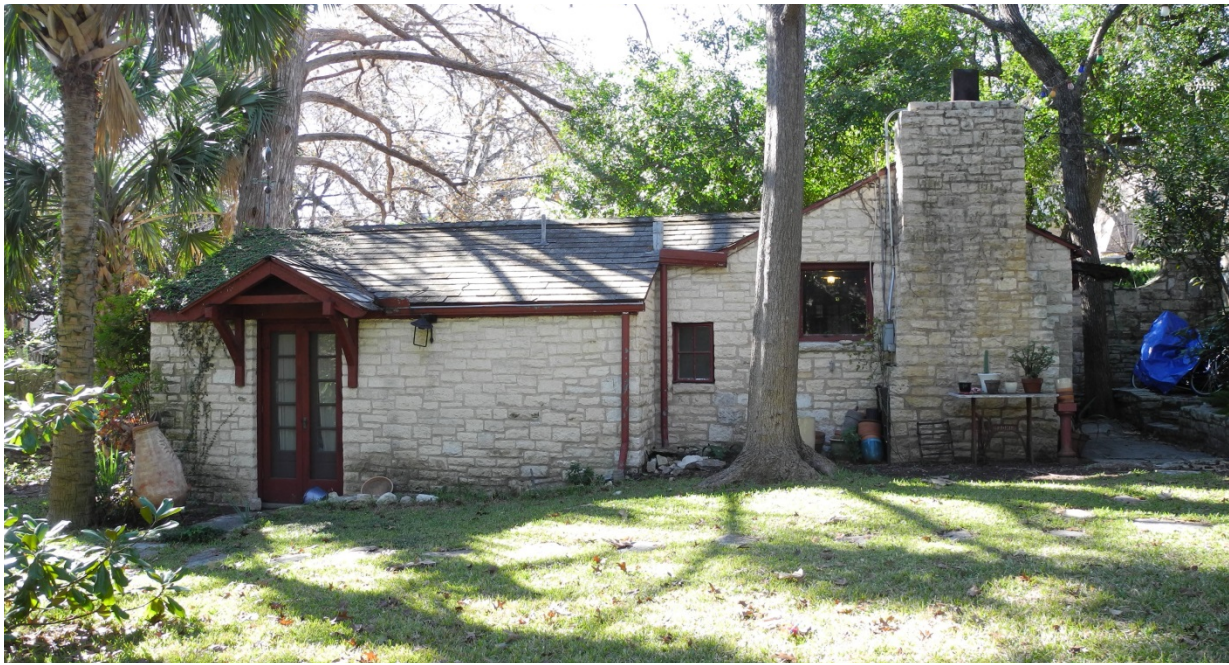
1-story stone cottage comprised of intersecting gabled wings designed by Austin architect Arthur Fehr in 1938 in the NPS Rustic style of his Bastrop State Park commissions. Gabled entry porch supported by wood brackets. Character-defining stone chimney on primary façade. Small gabled entry porch supported by oversized wood brackets. Cottage is an outstanding example of the NPS Rustic style applied to domestic use, reflects historic and architectural trends, and contributes to the historic district.

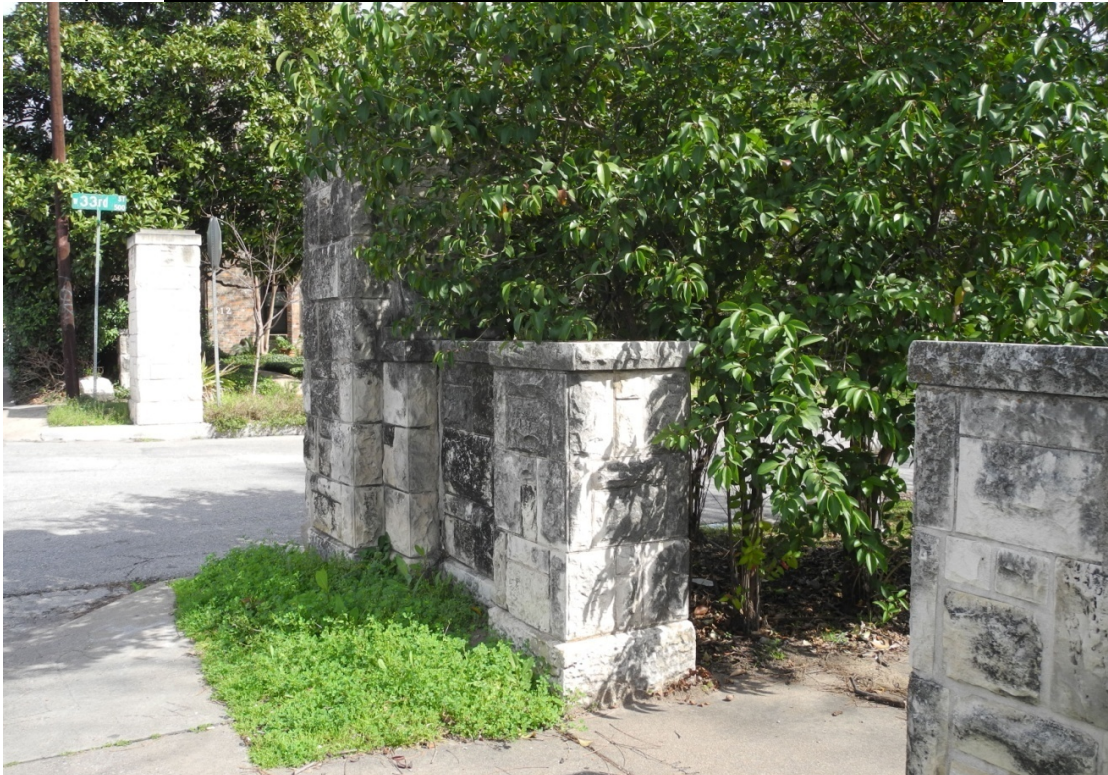
A hallmark of the early 20th century City Beautiful movement, a pair of 2-tiered rusticated limestone entry gates flank 32nd Street at its intersection with Speedway Blvd. The words "Aldridge Place" are incised on outward-facing stone panels set into the tallest columns. Bulb-like light fixtures, similar to neighborhood streetlights, surmount the pillars. Excellent, intact example of Rustic style "street furniture". Retains high level of integrity, reflects historic and architectural trends of its time, and contributes to the historic district.
