Aldridge Place Local Historic District

HISTORIC STRUCTURES SURVEY

ADDRESS: 3006 HEMPHILL PARK

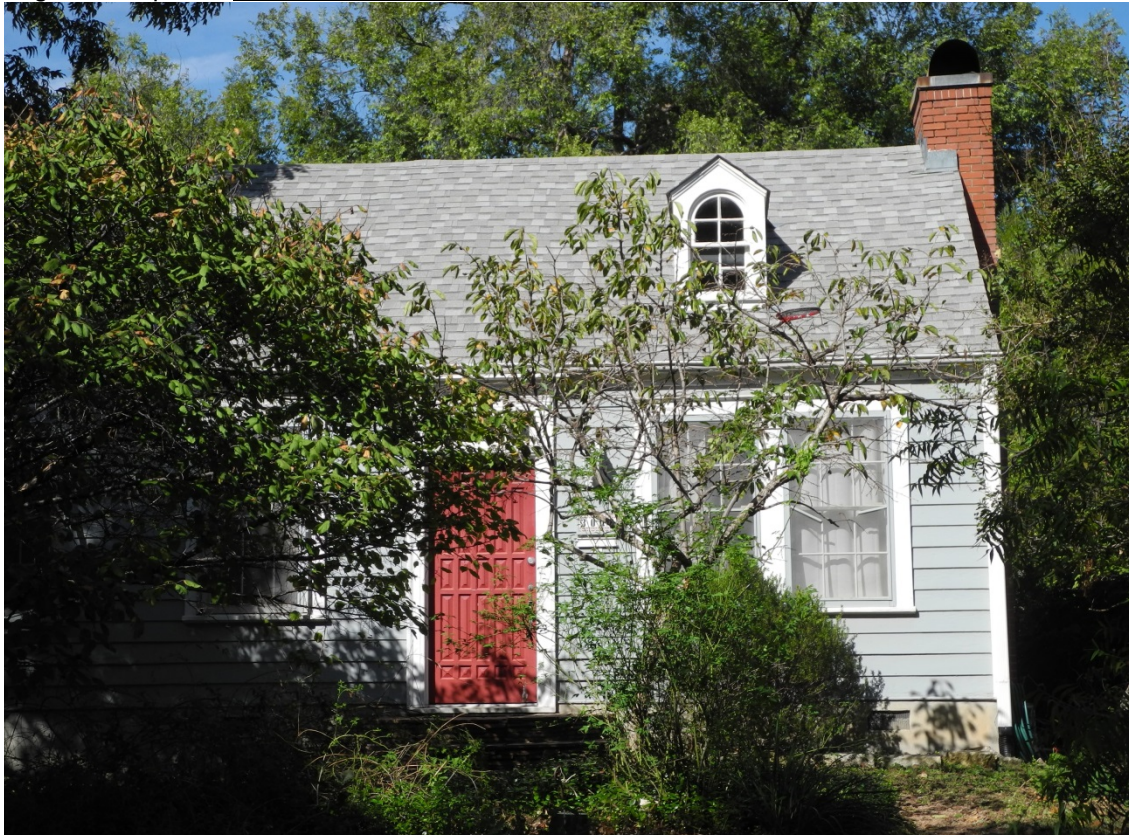
MAP KEY NUMBER: 99

Diminutive one story, side-gabled Colonial Revival style house with symmetrical façade and small gabled dormers containing multi-light arched windows. Flush entry with transom, no porch. Red brick chimney and landing. Intact Colonial Revival style cottage retains a high level of all 7 aspects of integrity, reflects historic and architectural trends of its time, and contributes to the historic district.

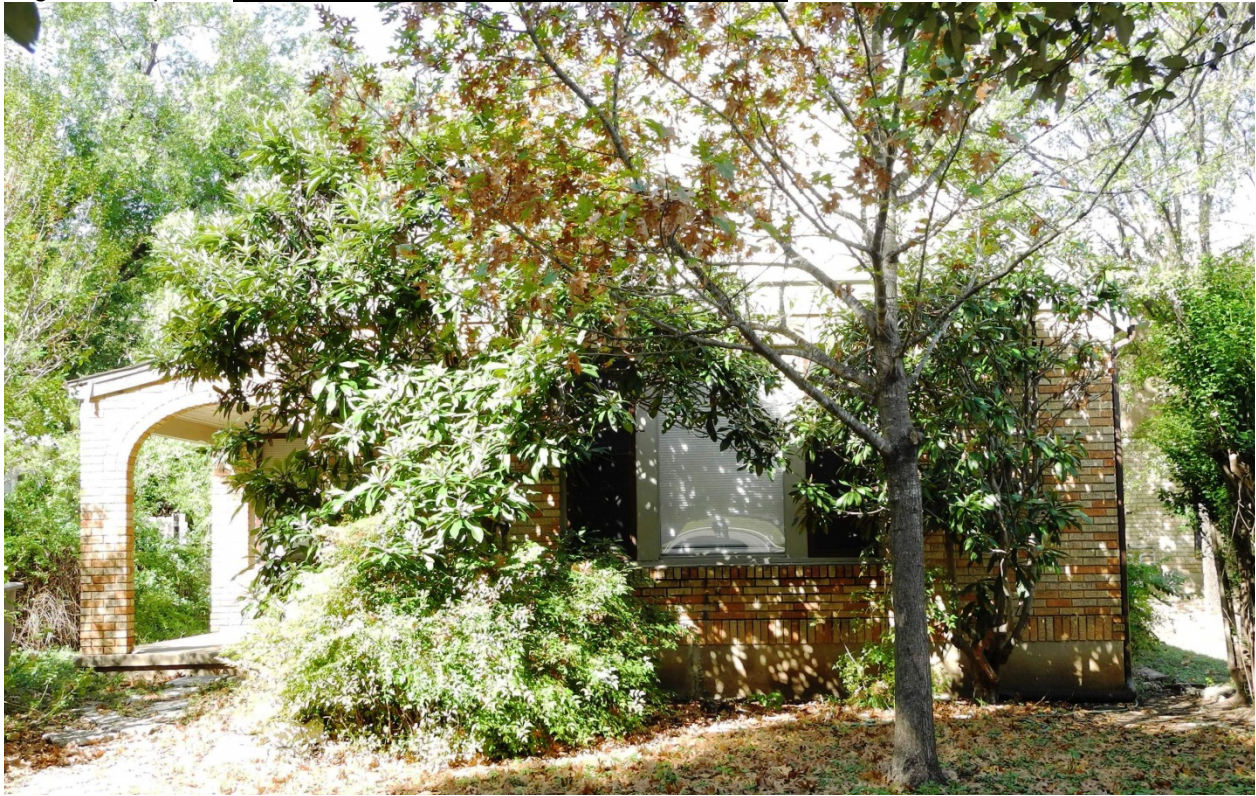
MAP KEY NUMBER: 100

One story, cross gabled, brick veneer Tudor Revival house with catslide roof over inset porch with brick arcade and columns. Stucco and faux half-timbering in gable ends. Tripartite window on north and fixed metal windows in center. Stone walkway from curb to entry. Soldier course brick water table. Good largely intact example of a Tudor Revival bungalow, retains high level of all 7 aspects of integrity, reflects historic and architectural trends of its time, and contributes to the historic district.

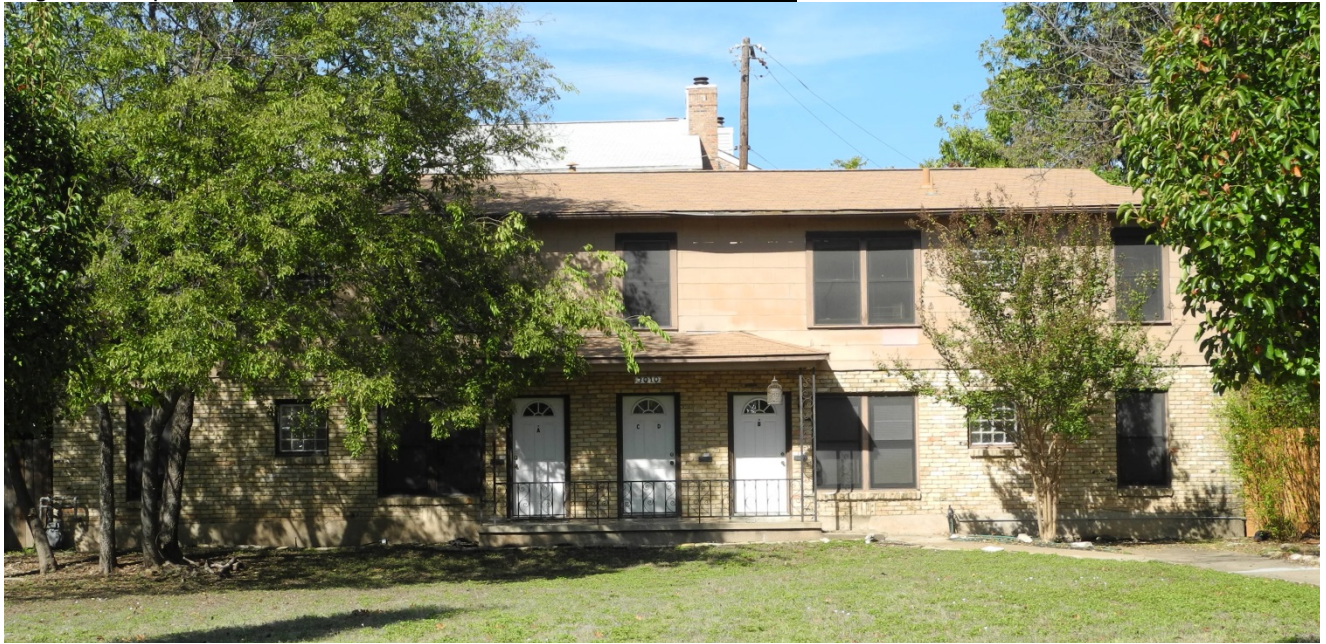
MAP KEY NUMBER: 101

Two story 4-unit postwar apartment house with side gable-on-hip roof, brick veneer on the first floor, asbestos on second. Centered hipped roof porch supported by fabricated metal posts and with metal handrails. Glass block accent windows toward ends on both floors. Concrete porch floor. Early postwar apartments retain historic integrity, reflects historic and architectural trends of its time, such as small-scale apartments in residential neighborhoods, and contributes to the historic district.

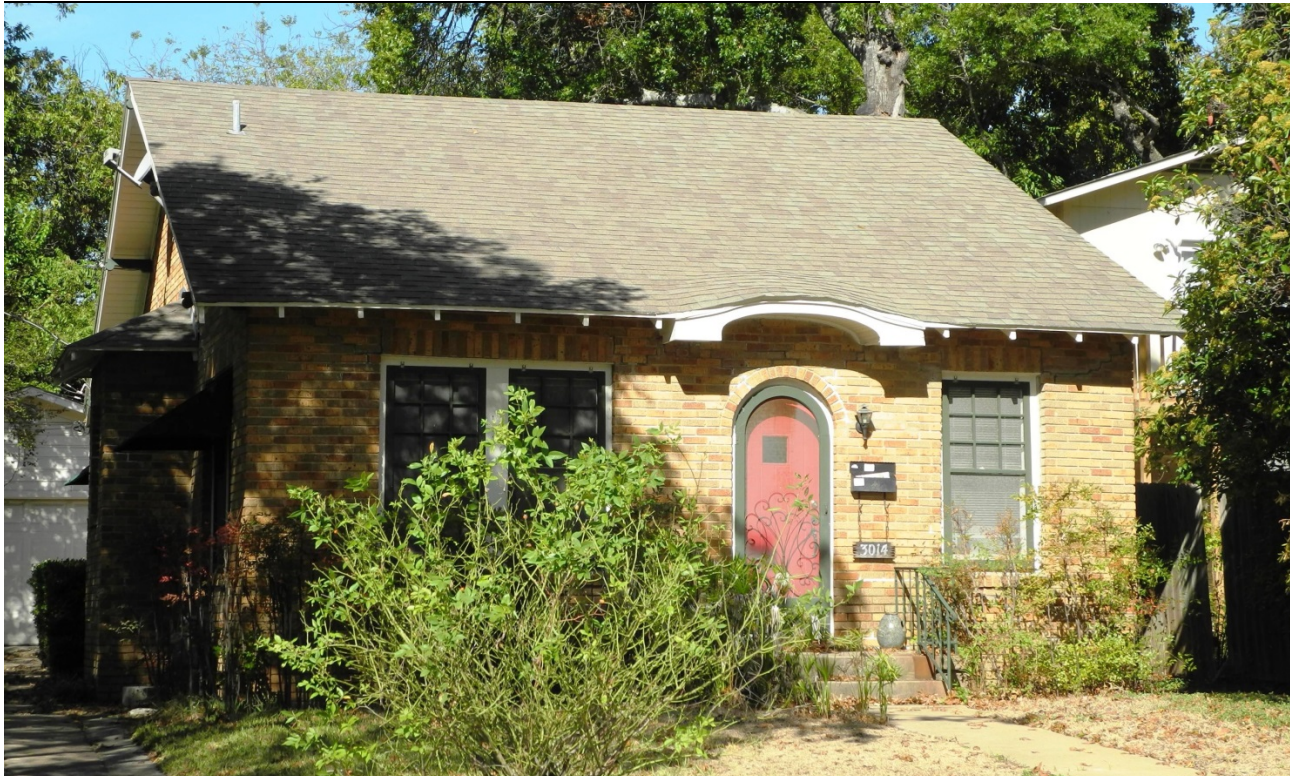
MAP KEY NUMBER: 102

Diminutive one story side-gabled brick bungalow with simple Craftsman details such as exposed flat brackets, small swept gable over entry door. Brick extension on south side. Decorative round-arched door and screen defined by arched end course brick. Paired and single 1/1 sash. Door has square glazing. Good, modest Craftsman bungalow retains high level of all 7 aspects of integrity, reflects historic and architectural trends of its time, and contributes to the historic district. Set back inconspicuous addition.

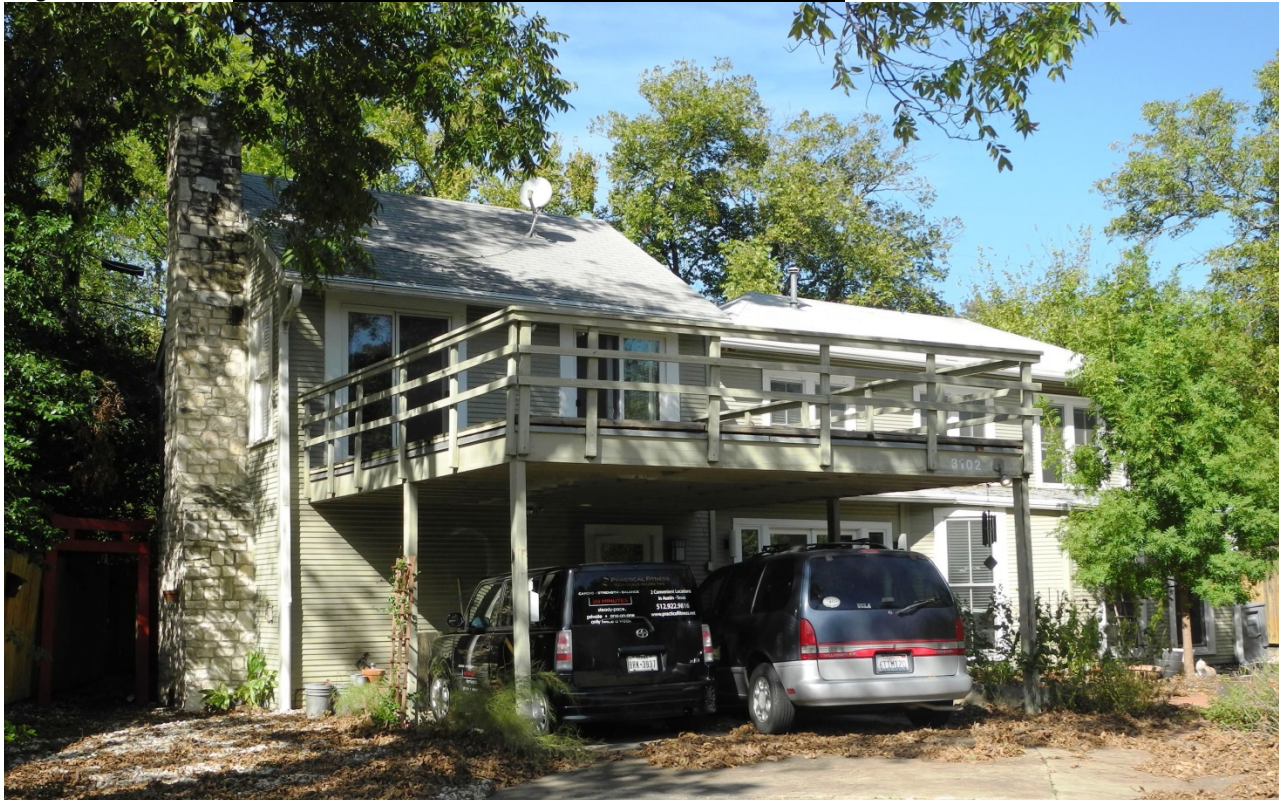
MAP KEY NUMBER: 103

Two story, hipped and gabled dwelling built in different building campaigns in different periods. C.1900 2/2 windows and bay window may have been taken from an older house. Massive stone chimney on south wall. Brick patio and large wood deck on primary façade detract from historic character. House exhibits no distinctive style or period. Design, plan, materials are incongruous, Large modern elements on front façade detract from historic character. Noncontributing resource.

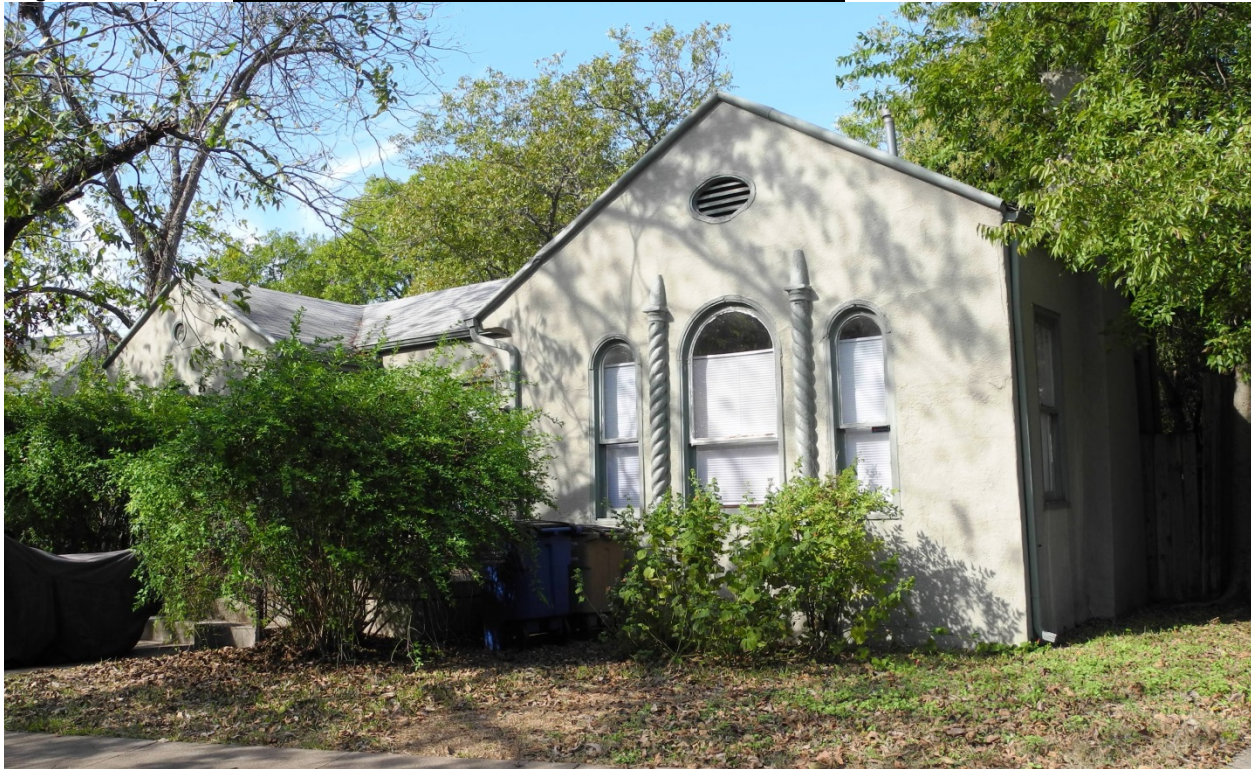
MAP KEY NUMBER: 104

One story U-plan Spanish Eclectic duplex with two front-gabled wings linked by a narrow, open terrace. Stucco sheathing and details. Arched Palladian-type windows accentuated by spiral pilasters; tripartite 1/1 double hung sash on connecting wing. Decorative oval-shaped wood gable vents. Original wrought iron exterior porch lights. Excellent example of a one-story Spanish Eclectic dwelling retains high level of all 7 aspects of integrity, reflects historic and architectural trends of its time, and contributes to the historic district.

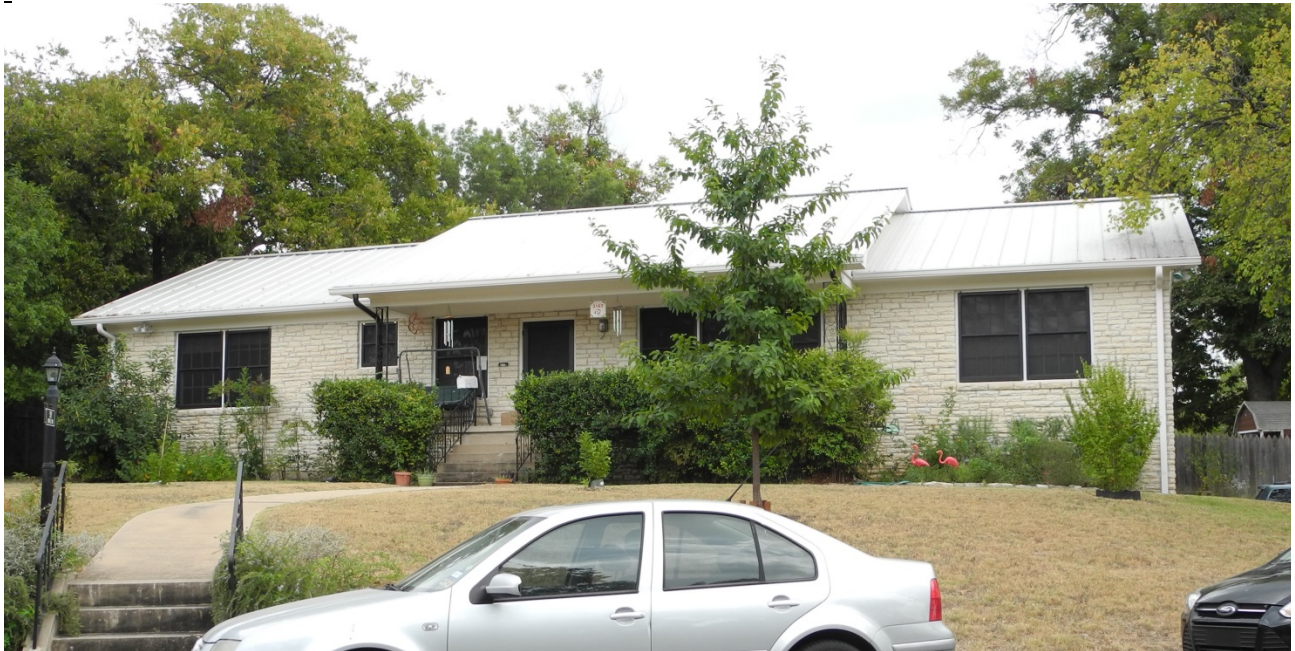
One story, rusticated cut limestone Early Ranch style house with a side-gabled roof. Symmetrical 3-part façade, slightly elevated center section has extended roof to cover inset porch supported by fabricated metal posts. Metal filigree posts and railings. Wood windows are 8/8 in pairs and triple sets. Good example of Early Ranch style. Retains high level of all 7 aspects of integrity, reflects historic and architectural trends of its time, and contributes to the historic district.

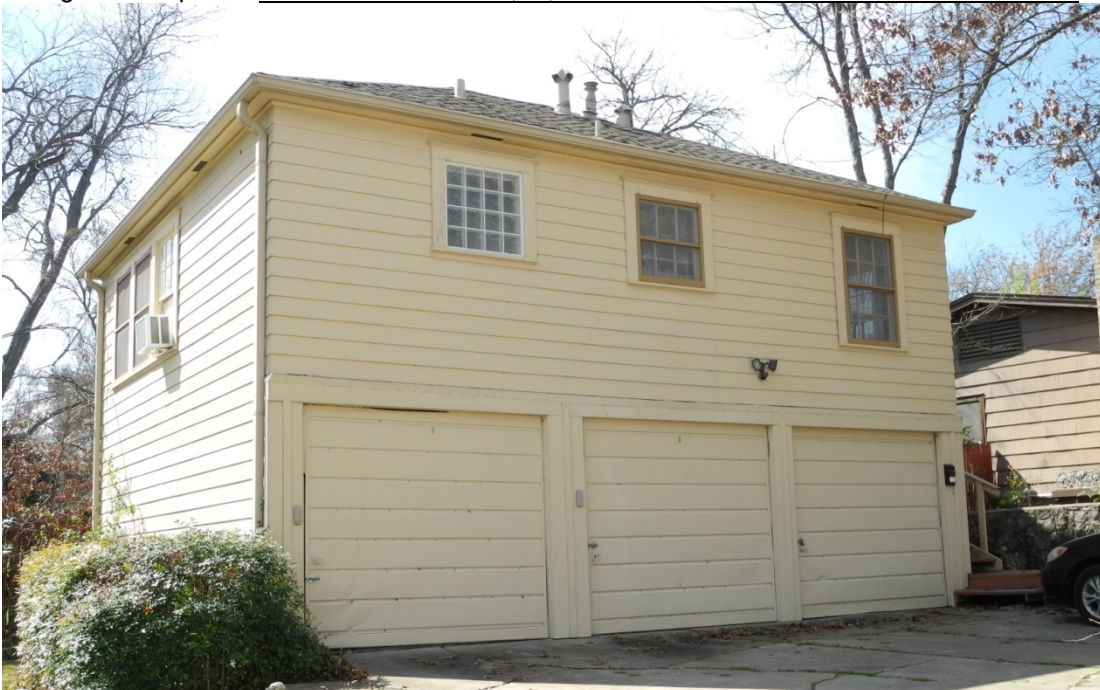
2-story, pyramidal roofed 3-car garage with wood lap siding on both levels. Horizontal wood plank garage doors are likely replacements for original wood doors with glazing. Upstairs apartment has 6/6 wood windows and is accessed by an exterior staircase under a shed roofed entry porch. Historic garage apartment has intact bays, though doors may be replacements. Overall, the building retains good integrity, reflects historic and architectural trends of its time, and contributes to the district.
