Aldridge Place Local Historic District

HISTORIC STRUCTURES SURVEY

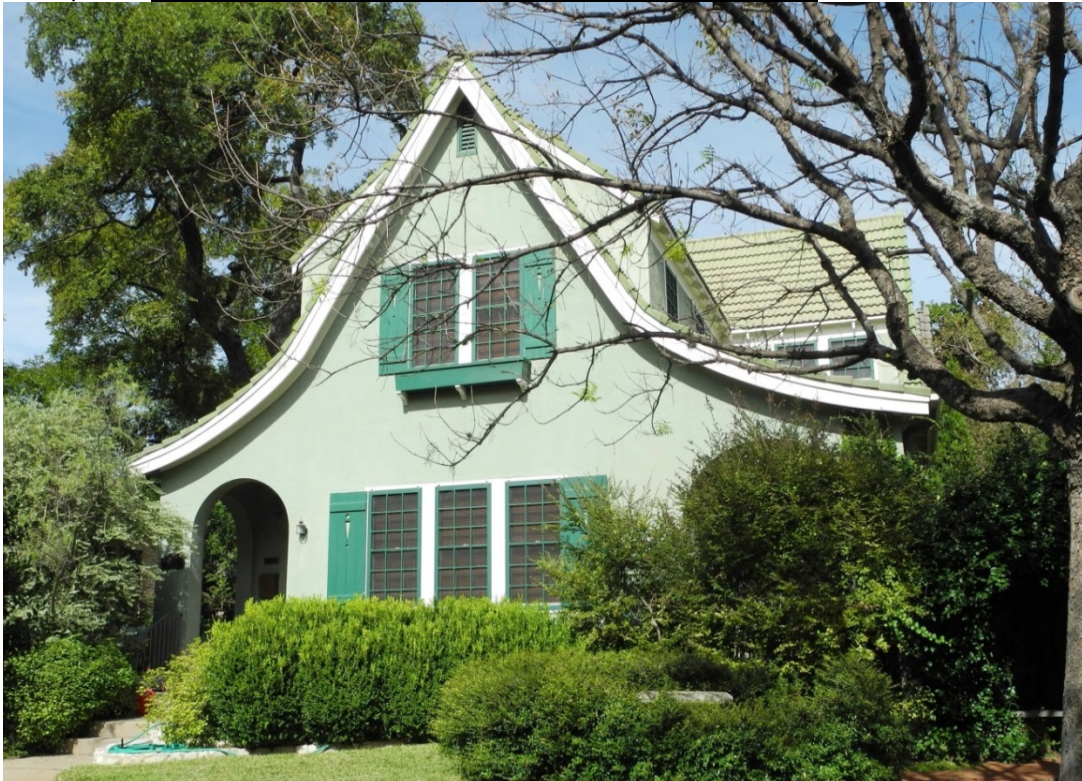
ADDRESS: 100 LAUREL LN

2-story stucco Tudor Revival house with a high-pitched, sweeping front gable ending in matching wing walls with arched entries to inset porches. Front gable has shed-dormers on sides, paired windows with planter box on front. Secondary high-pitched cross gable. Green clay tile roof with decorative flat brackets. Matching, nonhistoric garage. Exuberant, intact Tudor Revival style house retains a high level of all 7 aspects of integrity, reflects historic and architectural trends of its time, and contributes to the historic district.

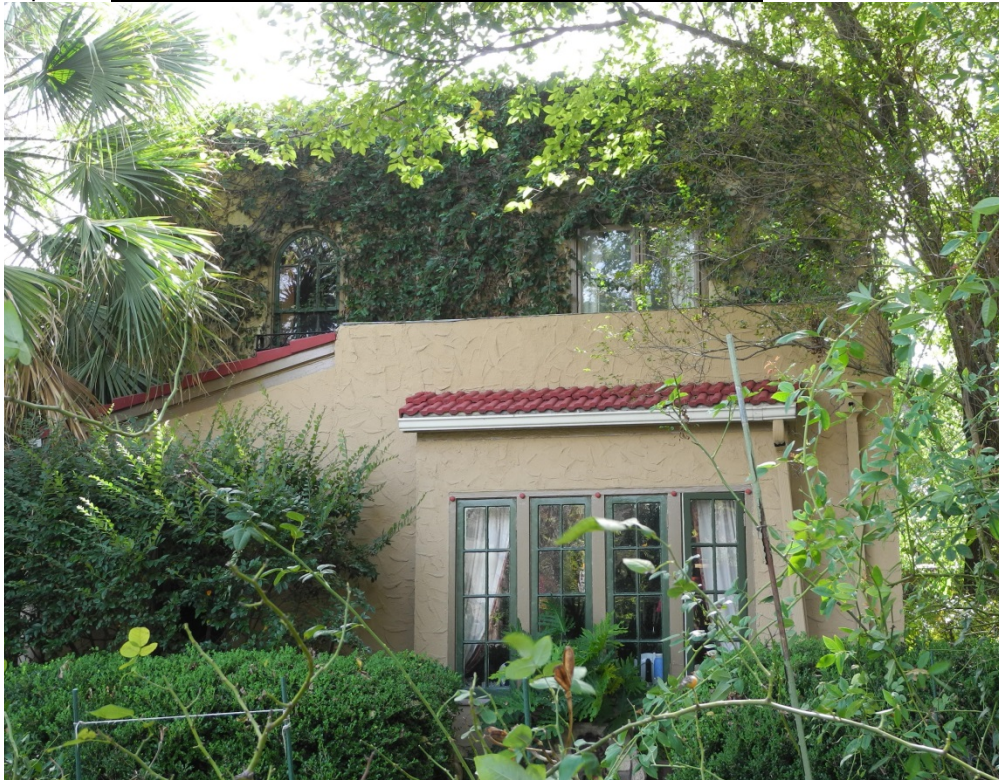
ADDRESS: 101 LAUREL LN

1-2-story Spanish Eclectic house with stucco siding, flat and gabled roof forms with red clay tiles. Clay tile awnings. Arched front and side porches; front enclosed with glass and accessed by French doors. Twisted plaster columns with Corinthian capitals. Arched multi-light window on second floor; paired wood casements on first floor front. Extensive plantings obscure house and details somewhat. Spanish Eclectic house retains a high level of all 7 aspects of integrity despite glass porch enclosure, reflects historic and architectural trends of its time, and contributes to the historic district.

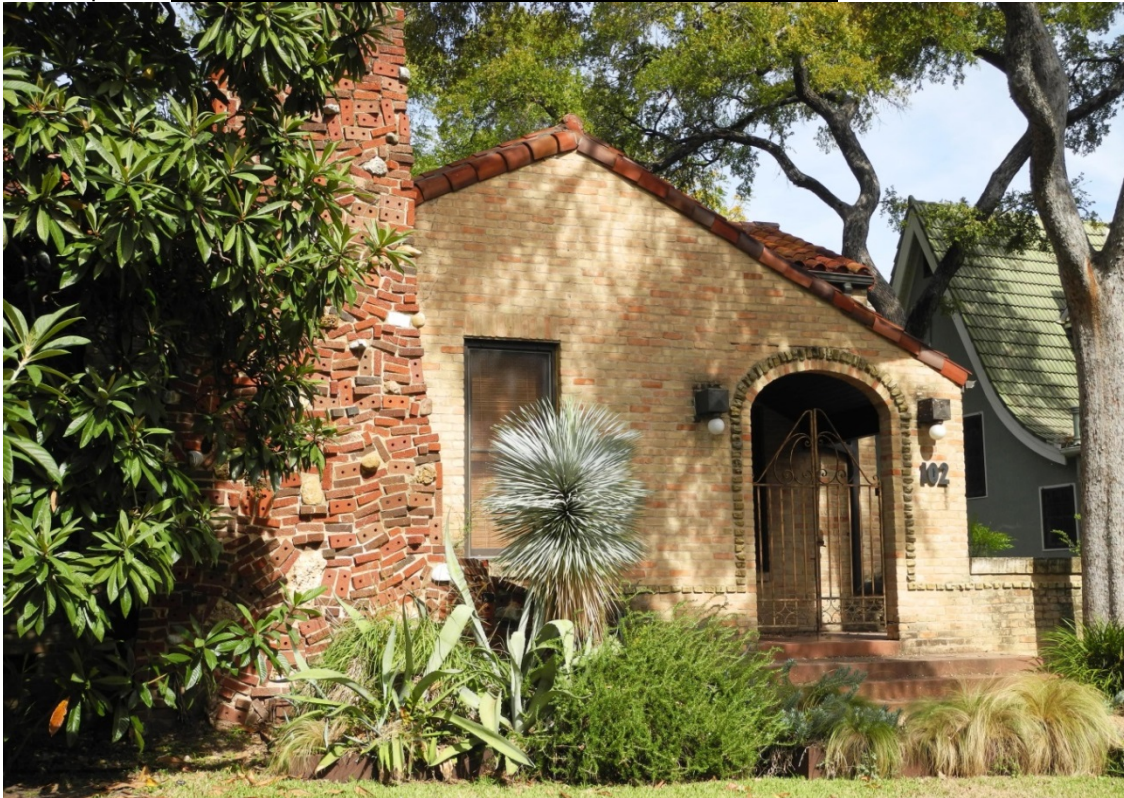
ADDRESS: 102 LAUREL LN

1-story brick veneer Spanish Colonial Revival Eclectic house with open arched porch outlined with small, individual stones and prominent free-form front chimney built of variegated clinker brick, fossils, and shells. Wrought iron gate into inset porch and adjacent terrace. Original metal light fixtures. Clay tile roof and canales. Excellent, unusual and intact Spanish Eclectic house retains a high level of all 7 aspects of integrity, reflects historic and architectural trends of its time, and contributes to the historic district.

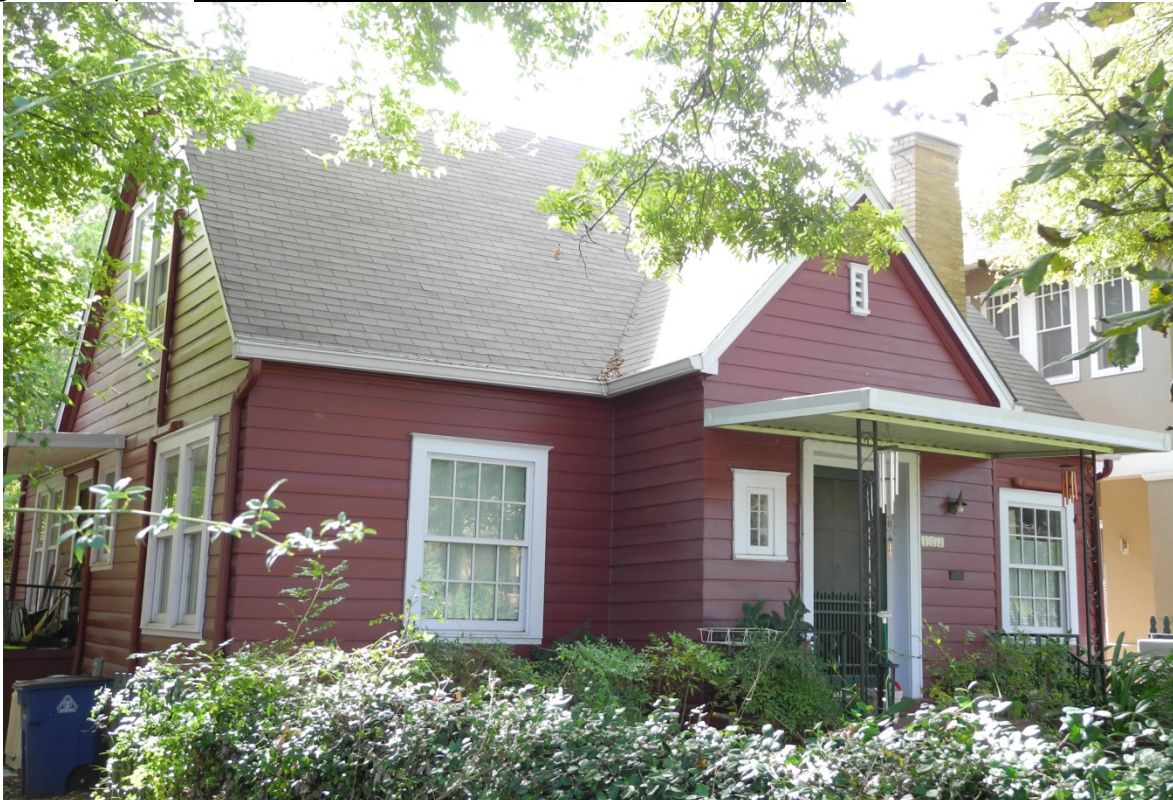
ADDRESS: 103 LAUREL LN

1 1/2-story cross-gabled vernacular frame house with slight Tudor Revival elements seen in high-pitched roof. Square inset porch under central front gable; small decorative 6-light window beside entrance. Flat aluminum front porch is replacement. Wrought iron handrails. Stepped and tapered chimney on front façade. Paired and single windows. Despite added porch, house retains a good level of all 7 aspects of integrity, reflects historic and architectural trends of its time, and contributes to the historic district.

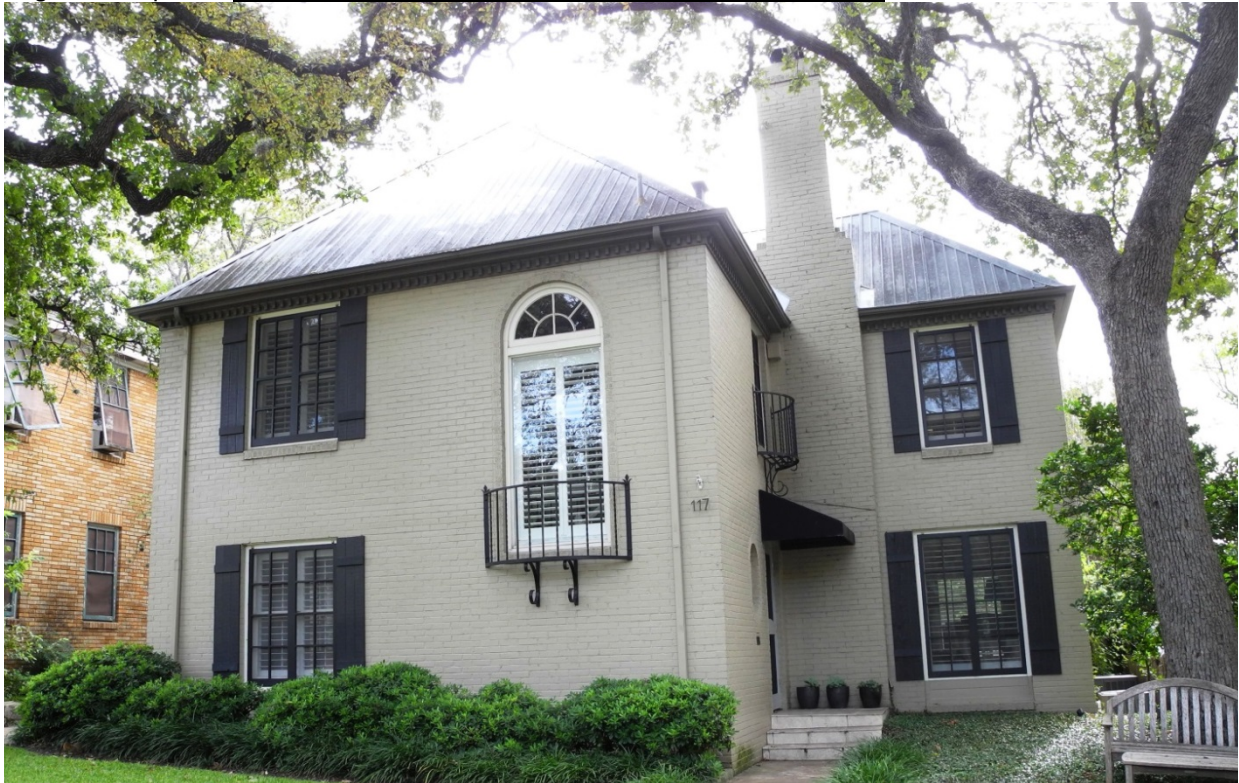
2-story painted brick hipped roof house with minimal Spanish Eclectic stylings. Fanlight above pair of vertical windows and wrought iron balconet on front façade. Matching balconet above front-side entry. Replacement windows, balconets, and roofing material; ornamental, inoperable shutters. New materials detract from historic character but house retains fair integrity of design, good level of other aspects of integrity, reflects historic and architectural trends of its time, and contributes to the district.

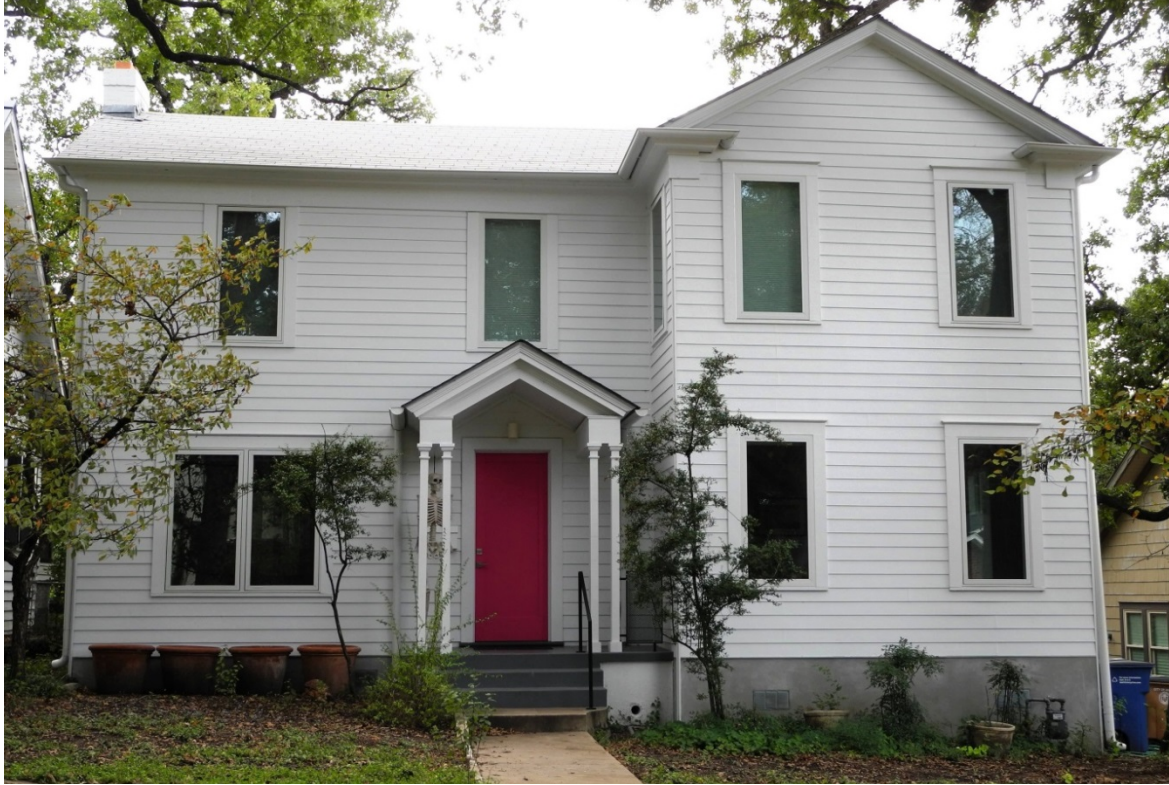
2-story cross gabled Colonial Revival L-plan house with wood lap siding, cornice returns, and pedimented entry porch supported by paired slender columns with detailed capitals. Single fixed replacement windows throughout; one pair on front. 2-story rear addition screened on 1st, enclosed on 2nd floors. Fixed replacement windows are incongruous with design but house overall retains good level of integrity, reflects historic and architectural trends of its time, and contributes to the historic district.

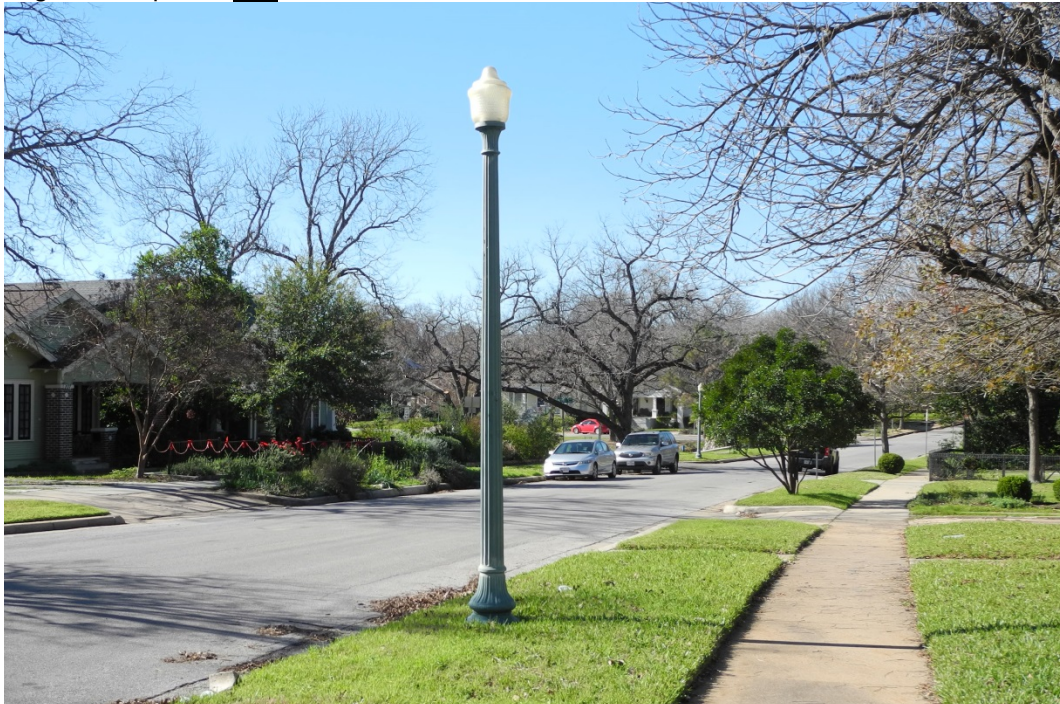
C. 1282 streetlights consisting of 12' raked cast iron posts surmounted by translucent bulbs. They are found at street intersections within the district and around Hemphill Park. The light fixtures match those mounted on the Aldridge Place entry gates on W. 32nd and 33rd streets. The street lights and gates were part of a district-wide landscaping theme that identified the subdivision as an exclusive and graceful residential enclave. The streetlights are of historic-age, retain all seven aspects of integrity, relate to important historic and architectural trends, and contribute to the Aldridge Place Historic District.

Some light posts in the district have been replaced with exact replicas of the originals; dates and locations of the replacement posts are unknown.

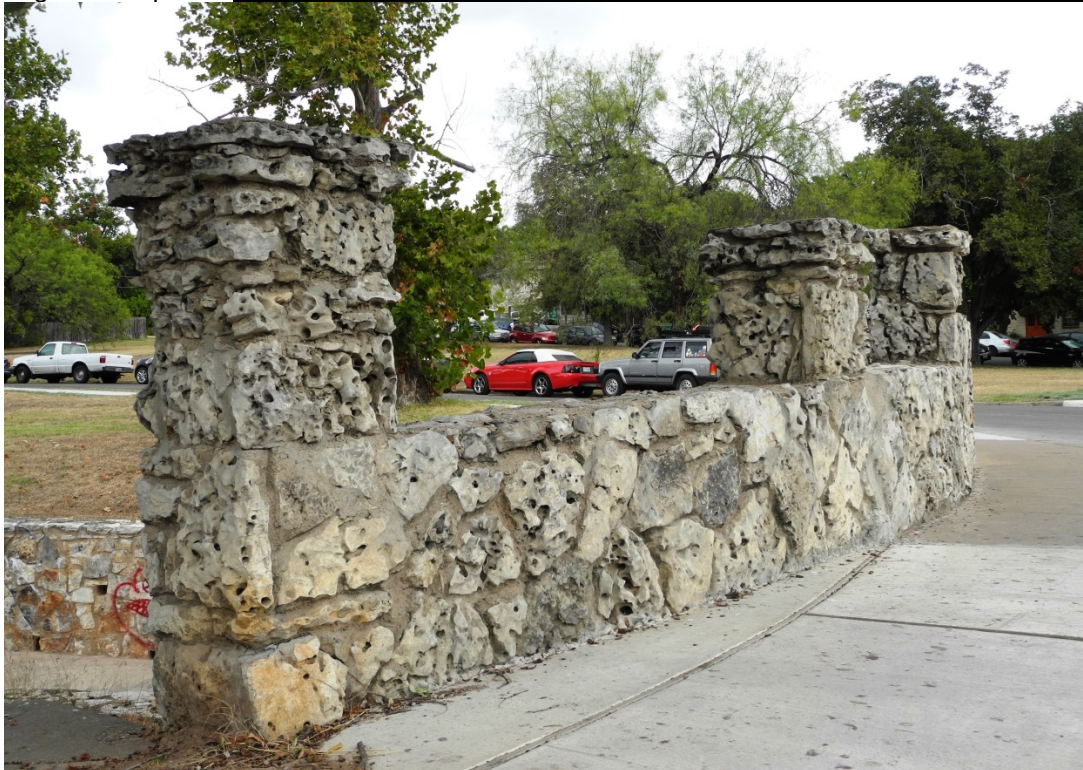
Legal Description: 30th STREET BRIDGE

A c. 1935 bridge over Waller Creek at 30th Street, reflects the "National Park Service Rustic" style of its time. The curved 2½' – 4½' traffic bridge is composed of local "honeycomb" limestone karst and cement mortar. Bridge marks the terminal end of neighborhood at its eastern boundary. Rustic bridge is in keeping with Craftsman aesthetic in the neighborhood. It retains a high level of integrity, reflects historic and architectural trends of its time, and contributes to the historic district.
